NASA Technical Paper 3265

Development of a Full-Scale Transmission Testing Procedure To Evaluate Advanced Lubricants

David G. Lewicki,
Harry J. Decker,
and John T. Shimski

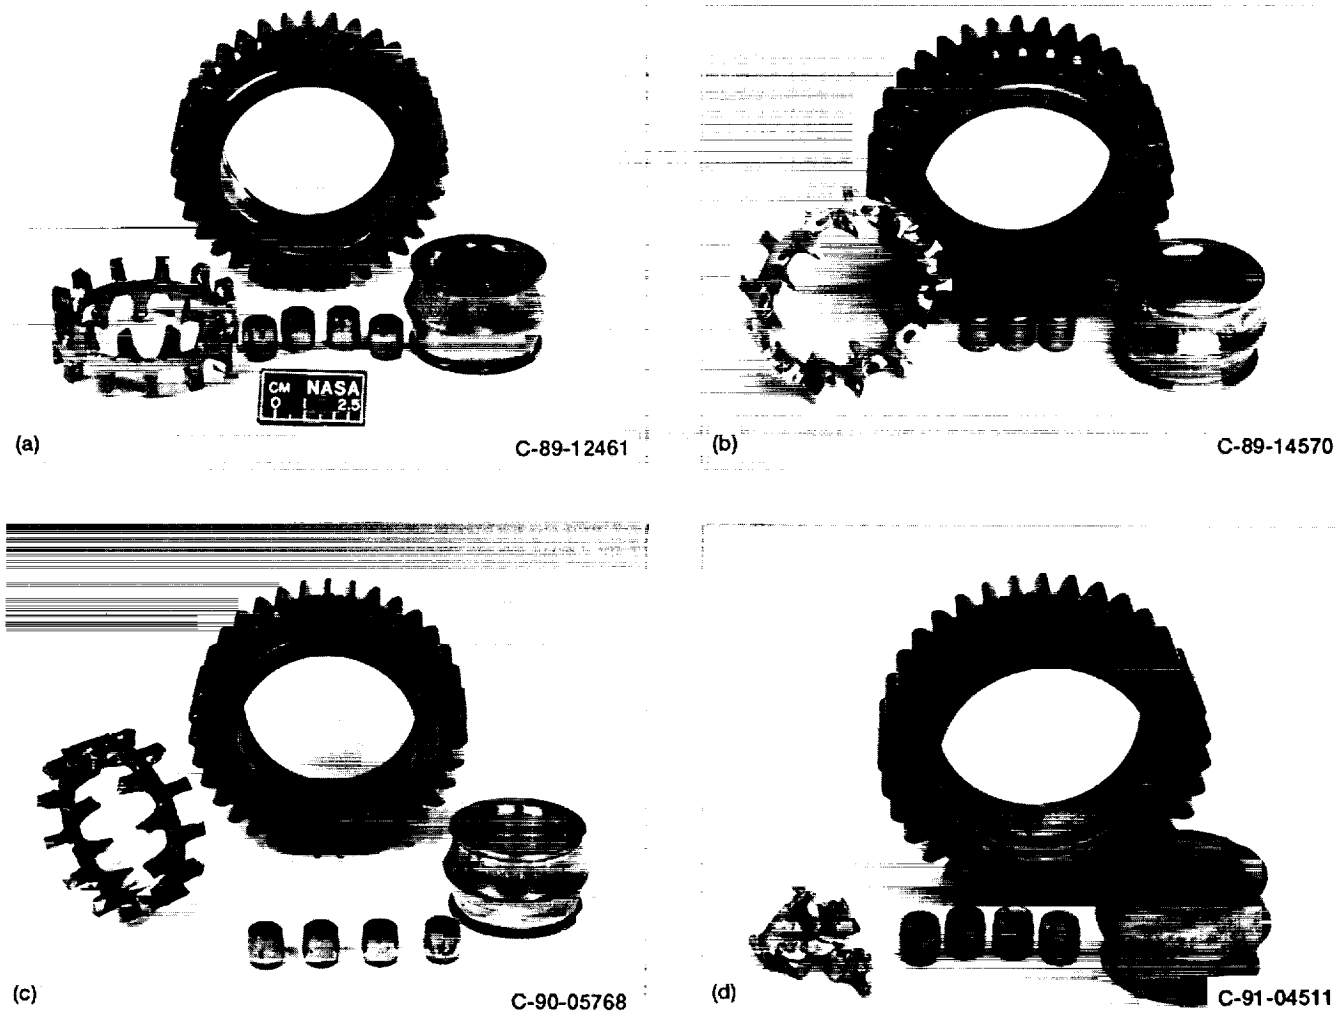
Figure 3.—OH-58A transmission planet bearing failures.

Planet bearing failures.—For MIL-L-23699 lubricant brand A, three planet bearing fatigue failures occurred. The first occurred on one of the original planet gears of the transmission during test 5 (serial number (S/N) B12-25780, fig. 3(a)). The failure was a fatigue spall on the inner race. The component acquired 1908 hr of run time (load spectrum unknown) before NASA testing, 71 hr in NASA test 1, 100 hr in test 2, 50 hr in test 3, 50 hr in test 4, and 16 hr in test 5. The 66 hr of run time from tests 3 and 5 were at operating conditions of 117-percent torque and 121 °C (250 °F) oil inlet temperature. It was assumed no overload occurred during the first 1908 fleet hours. On two other planet bearings, inner-race fatigue failures occurred at 117-percent torque and 121 °C oil inlet temperature. One occurred after 59 hr of test 5

(a) Serial number (S/N) B12-25780, fatigue failure during test 5.
(b) S/N B12-35194, fatigue failure after test 5.
(c) S/N B12-35181, fatigue failure after test 6.
(d) S/N B12-25580, cage failure after test 9.

(S/N B12-35194, fig. 3(b)) and the other after 75 hr of test 6 (S/N B12-35181, fig. 3(c)). All three failures were similar: the spalls covered both rows of each bearing and about one-third of each circumference.

For MIL-L-23699 lubricant brand B, one planet bearing cage failure was produced after 91 hr of test 9 (S/N B12-25580, fig. 3(d)). This failure was catastrophic; the cage for one of the planet bearings was destroyed and the rollers and raceways showed excessive scoring and distress.

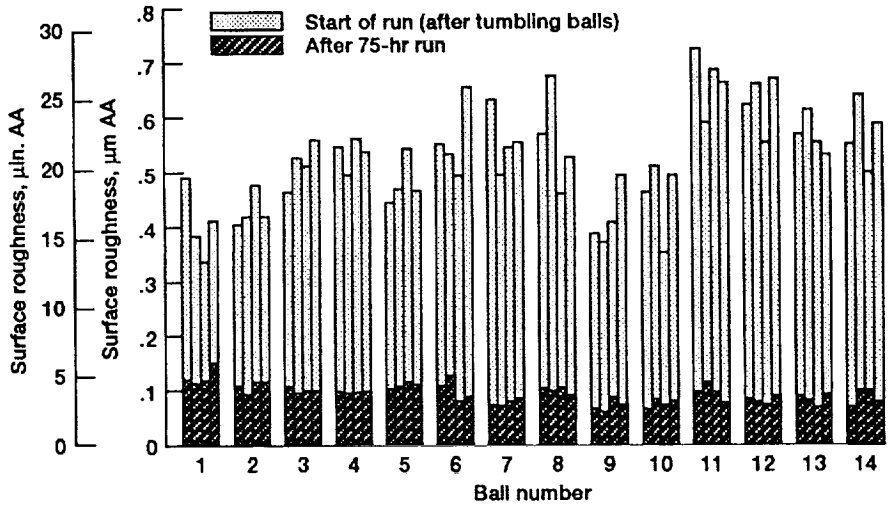
Figure 6.—Surface roughness measurements of balls for OH-58A transmission mast-shaft ball bearing, S/N 2512.

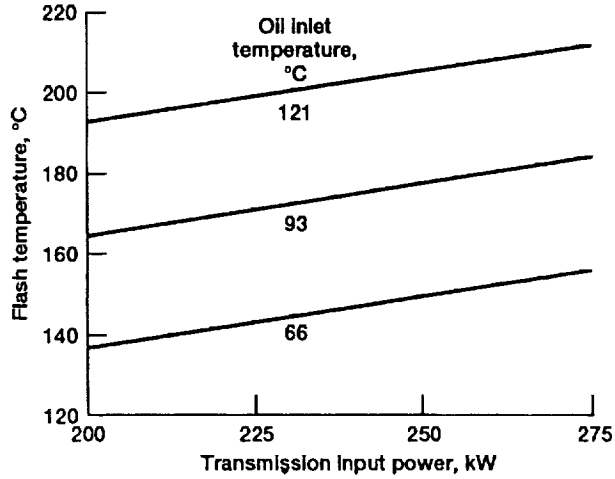
At present, there is little agreement about the best method for evaluating spiral bevel gear scoring (ref. 13). Formulas for rating scoring resistance of bevel gear teeth are not included in AGMA standards. The method used to evaluate bevel gear scoring of the OH-58A transmission considered the flash temperature (defined as the total tooth surface temperature as it engages in mesh) compared to an assumed allowable value (ref. 14). Using this method, the flash temperature as a function of oil inlet temperature and transmission input power was estimated (fig. 8). For all conditions in figure 8, the predicted flash temperatures were below the assumed allowable for AISI 9310 gears (the material of the OH-58A spiral bevel gears) with MIL-L-23699 lubricant, indicating a low probability that scoring would occur.

Figure 8.—OH-58A spiral bevel mesh flash temperature predictions. Allowable flash temperature to resist scoring = 257 °C for AISI 9310 gears with MIL-L-23699 lubricant (ref. 14).

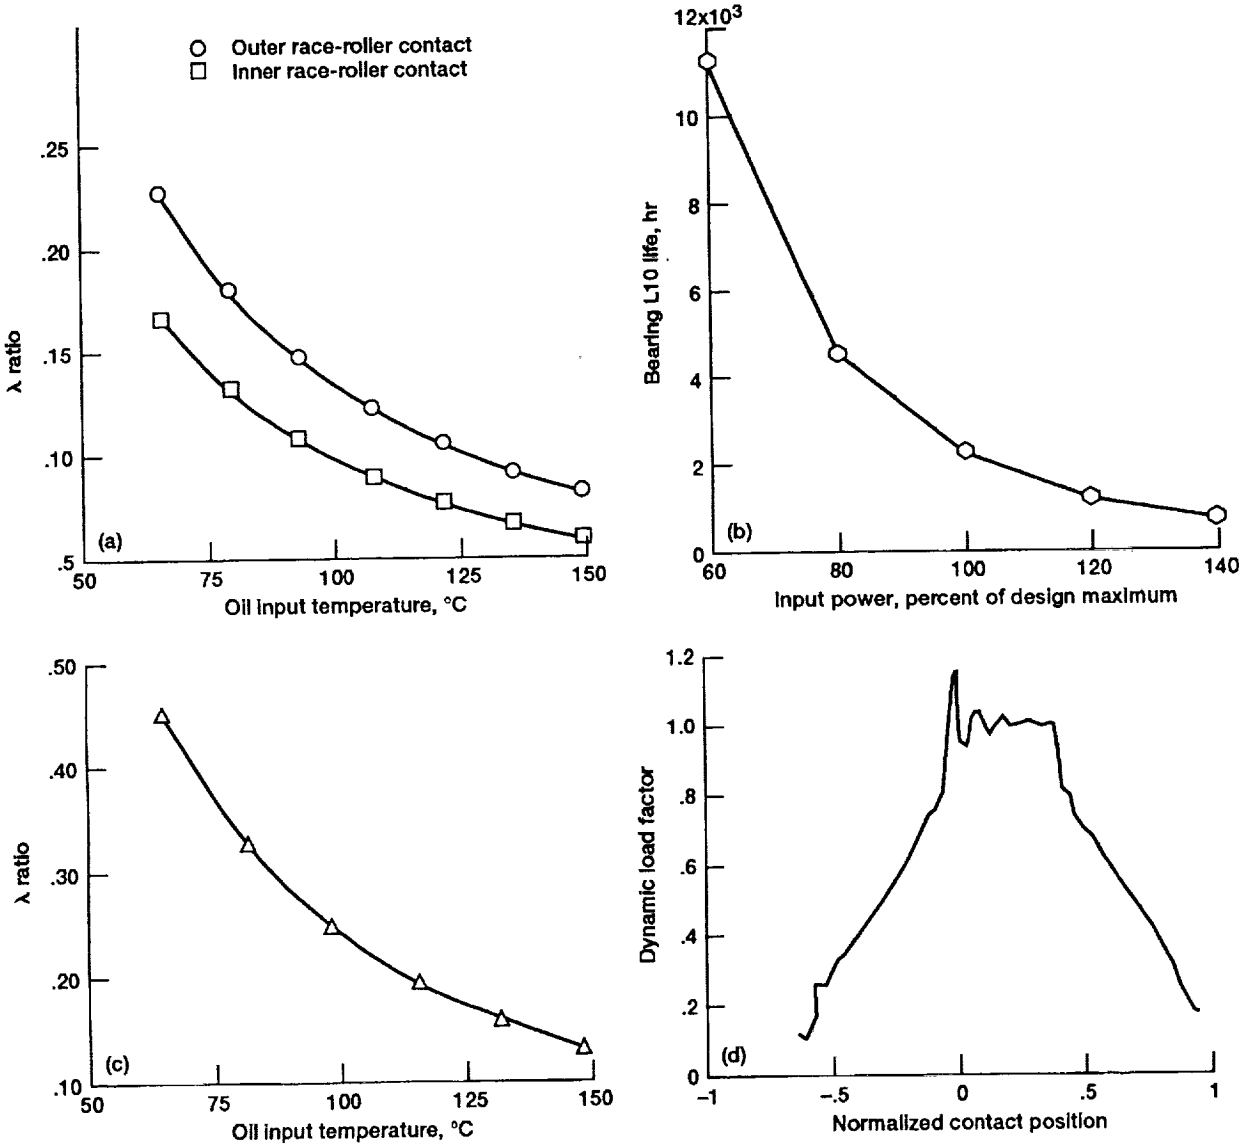
Figure 9.—OH-58A transmission planet gear and bearing analysis.

The predicted film thickness was extremely low, primarily because of the relatively low bearing speed (fig. 9(a)). At

79 °C (175 °F) oil inlet temperature, the calculated λ ratio (defined as the film thickness divided by the composite surface roughness) was 0.18 for one row of the outer race-roller contact and 0.13 for the inner race-roller contact. At these low λ values, a significant reduction in bearing life is predicted using American Society of Mechanical Engineers (ASME) design guides (ref. 16). In fact, the predicted λ values were lower than the lower limit of the ASME charts. As the bearing temperature increased, the predicted λ values decreased even further because of the lubricant's decreased viscosity. The predicted film thickness was not significantly affected by bearing load for the cases studied (60- to 140-percent of design maximum).

The effect of load on predicted bearing fatigue life is shown in figure 9(b). For these cases, the lubricant life adjustment factor based on the calculated λ ratio, as recommended by ASME (ref. 16), was constant at 0.21. From the predictions, the bearing was moderately loaded (maximum Hertz stress of 1.44×10^6 kPa (209 ksi) at 100-percent design maximum load). The predicted life was not affected by operating temperature for the cases studied (66 to 149 °C oil inlet). The reason was that the temperature effect on life was only considered in the lubrication life adjustment factor (which was constant at 0.21 for all cases, since the predicted λ ratios were lower than the lower limits of the ASME charts).

The predicted λ ratio was extremely low, about twice that of the planet bearing (fig. 9(c)). With increased temperature,

(a) Planet bearing single row film thickness at 100-percent design maximum load.
(b) Planet bearing life at 93 °C oil temperature.
(c) Planet gear film thickness at 100-percent design maximum load.
(d) Sun-planet gear dynamic load at 100-percent design maximum load.

the predictions portrayed trends similar to those of the planet bearing. The dynamic load factor (defined as the tooth dynamic load divided by the static load) as a function of normalized contact position (defined as the contact position divided by the base pitch) is shown in fig. 9(d). This curve was similar to a static load case indicating a low-speed condition and no dynamic loading. The low values predicted for film thicknesses and dynamic loads indicated the planet gear and bearing operate in a relatively low-speed regime. This would imply a greater probability of surface related problems, meaning the influence of the lubricant could be significant.

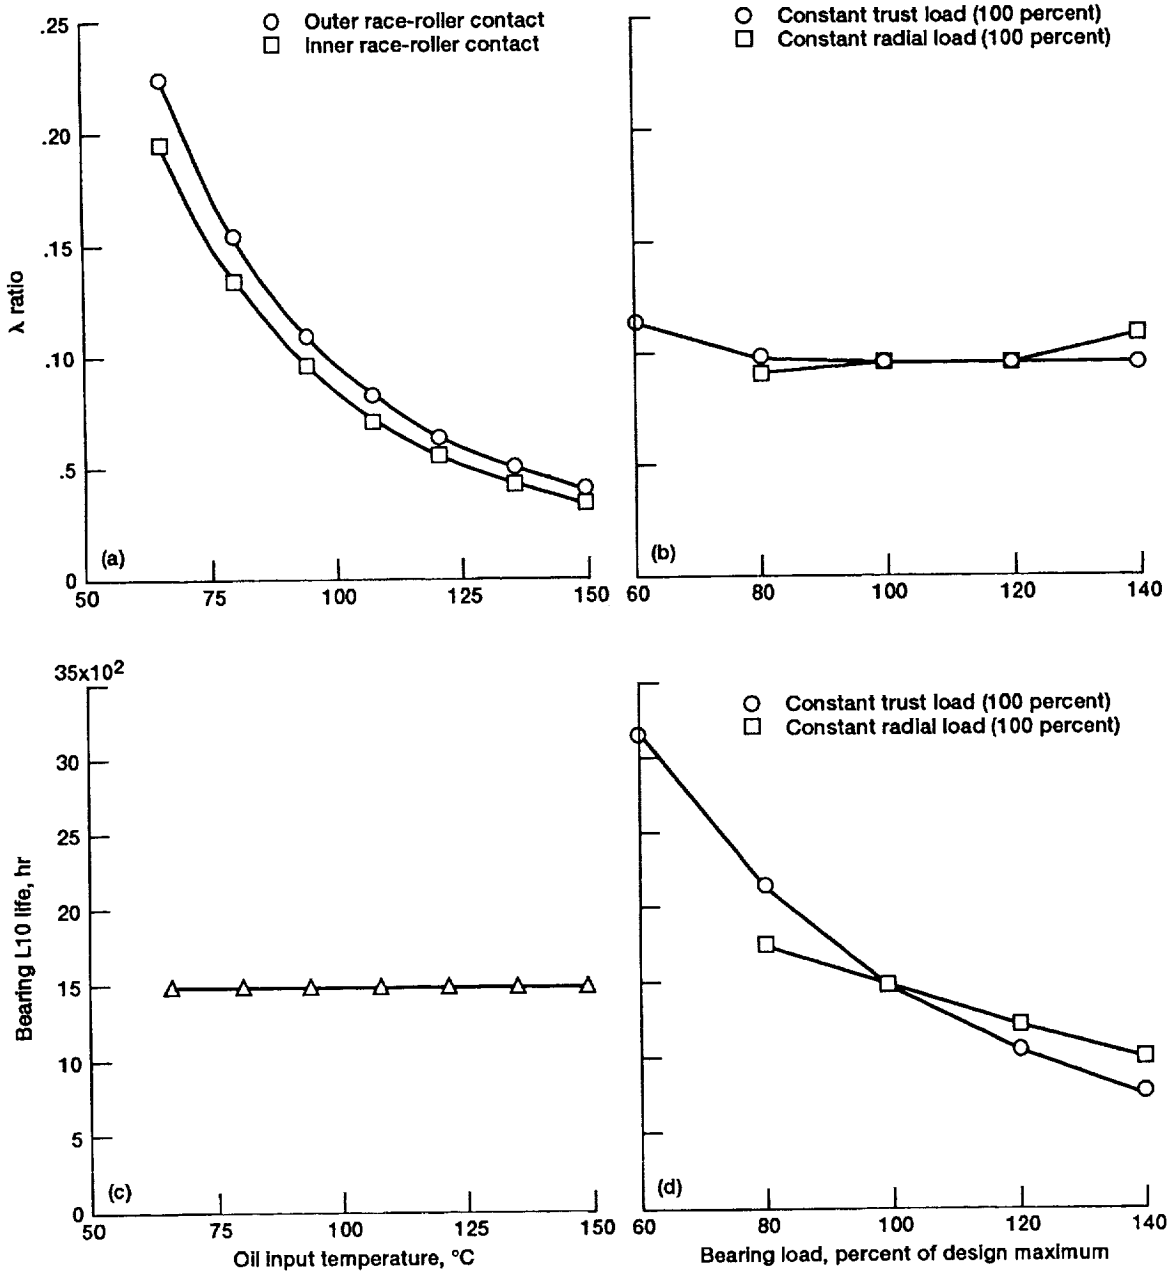
Figure 10.—OH-58A transmission mast-shaft ball bearing analysis.

(a) Film thickness at 100-percent design maximum loads.
(b) Inner race-ball contact film thickness at 93 °C oil temperature.
(c) Bearing life at 100-percent design maximum loads.
(d) Bearing life at 93 °C oil temperature.

The predicted film thickness was extremely low because of the low bearing speed (fig. 10(a)). At 79 °C (175 °F) oil inlet temperature, the calculated λ ratio was 0.15 for the outer race-ball contact and 0.13 for the inner race-ball contact. As with the planet bearing, the predicted λ values were lower than the lower limit of the ASME charts. As the bearing temperature increased, the predicted λ ratios decreased even further because of the lubricant's decreased viscosity. The predicted film thickness was not affected by bearing radial or thrust loads (fig. 10(b)).

The predicted fatigue life of the bearing was not affected by operating temperature for the cases studied (fig. 10(c)). For these cases, the ASME lubricant life adjustment factor was constant at 0.21. Increased radial load had a more significant effect on predicted bearing life than did increased thrust load (fig. 10(d)), because the life calculation was
